## **PROJECT CASE STUDY** PORTSMOUTH CATHEDRAL: TOWER REPAIRS AND CHAPEL OF ST THOMAS STONEWORK

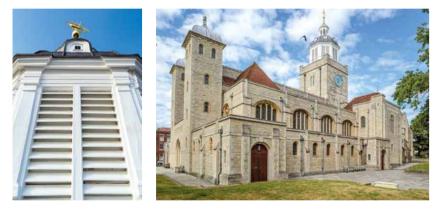
Extensive decay to the seventeenth century timber belfry and corrosion to key twentieth century steel beams put the listed Tower at serious risk.

The repair project was challenging because of the very restricted working area in the belfry which was further reduced by the numerous temporary props.
