# THE CATHEDRAL OF THE SEA

Portsmouth Cathedral: The tower and chancel repair project by Simon L Ablett, Cathedral Architect, Ablett Architects Ltd

Extensive decay to the landmark seventeenth century timber belfry and corrosion to key support beams put the cathedral tower at serious risk.

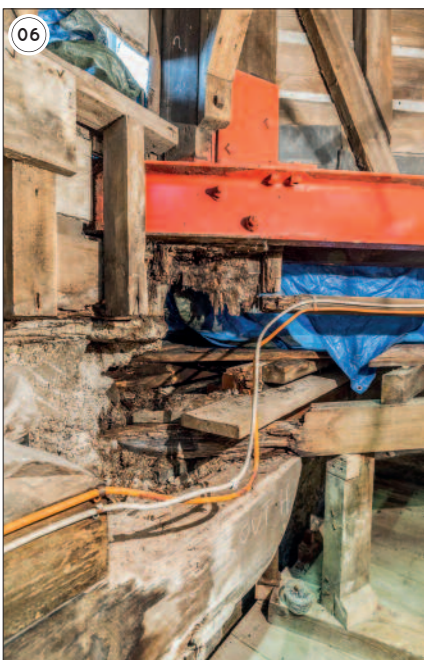
pensate for loss of key timbers by inserting steel channels across the corners. When these were exposed during the opening up work the outer channels were found to be very heavily corroded, with metal fragments falling away to the lightest touch.

The removal of the concrete in the belfry exposed completely rotten ends to key structural posts, some the timber had deteriorated to no more than a powdery dust, leaving pockets where timber had once been. There was also mass decay below the gutter timber-work. Water penetration must have occurred for a very considerable period of time as many timber connections, as well as key timber beams and supports, were completely rotten. >

**IMAGES:**  
**01** Exterior completed. **02** Dome repairs underway. **03** Decay exposed. **04** Golden Barque on display in the Cathedral. **05** Clock face. **06** Timber decay opened up in the belfry. **07** Work underway. **08** Compact working in the belfry. **09** Belfry completed. **10** Golden Barque being positioned at the top of the tower.

rary propping inserted and each area being repaired one corner at a time, with new oak lengths hoisted in, each adjusted and jointed to repair the existing. The philosophy was to retain as much sound original material as possible, however, the corroded steelwork was completely replaced.
