# PORTSMOUTH CATHEDRAL

by Simon L Ablett, Cathedral Architect

## Seeing the cathedral from a different viewpoint

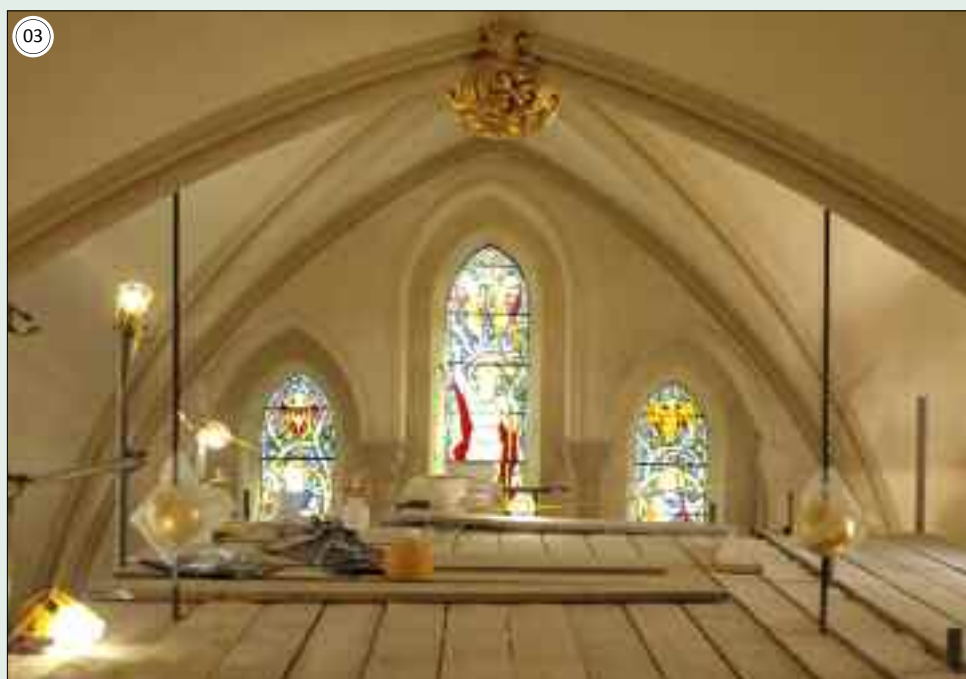
The evidence of water ingress on the north side of the quire was a particular concern and was due to poor detailing of the copper coverings of the three large dormer windows, but the glazing needed repair and general roof tiling was very uneven. Other roofs had slipped and missing tiles, cast iron rainwater downpipes were split and corroded, asphalt needed repair and the cross finials to the apex of the transepts were leaning at odd angles. Water was entering the earliest part of the cathedral and repairs were needed.

- 01 South Tower view
- 02 Quire towards organ  
© Jonty M Sexton
- 03 Chapel of St Thomas  
vault looking east
- 04 Quire ceiling during  
the works
- 05 The north roof in  
progress
- 06 The north roof in  
progress

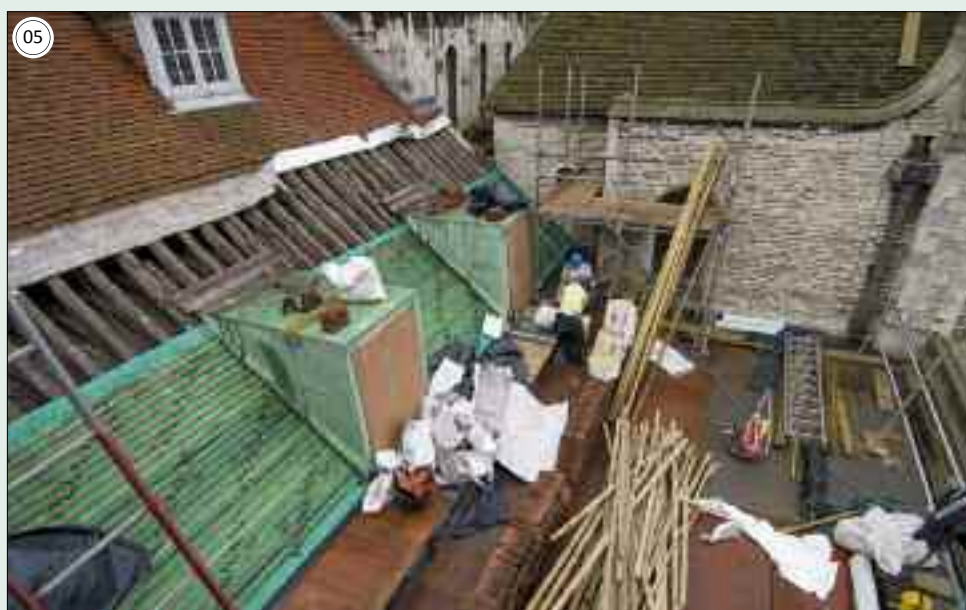
Approval was given by the Cathedrals Fabric Commission for England for the dendrochronological dating of the roof timbers above the chapel of St Thomas and the two transepts. In the case of chapel of St Thomas the felling date was identified during the period 1389-1421 and the north and south transepts the timbers are likely to date from 1693, which corresponds with the dated plasterwork at high level in the quire.

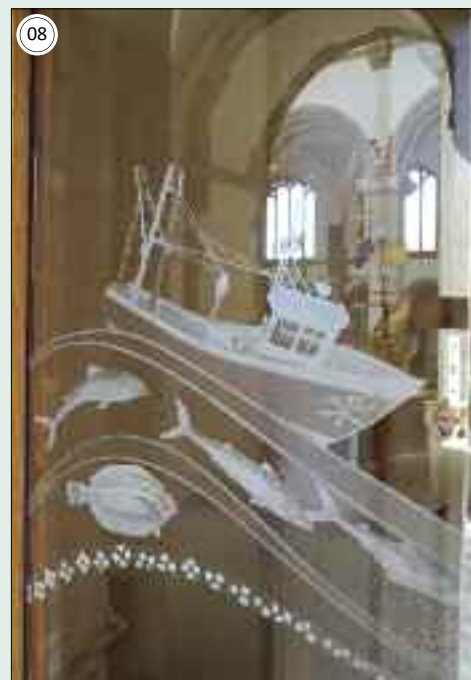
08 Glass doors after

porch appeared rather forbidding and not welcoming alteration to the outer panelled doors was undertaken and a new set of inner oak doors with large engraved glass panels by Tracey Sheppard were installed. Tracey's work is a pleasing contemporary design and includes symbols of baptism, references to the Portsmouth fishing fleet and the sun as a symbol of Christ, with the names of the donors in the panels above the doors. The glass allows views into the interior as well as natural light to permeate into the former gloomy entrance area. This work adds a suitably twenty-first century layer to a cathedral of many periods. ■

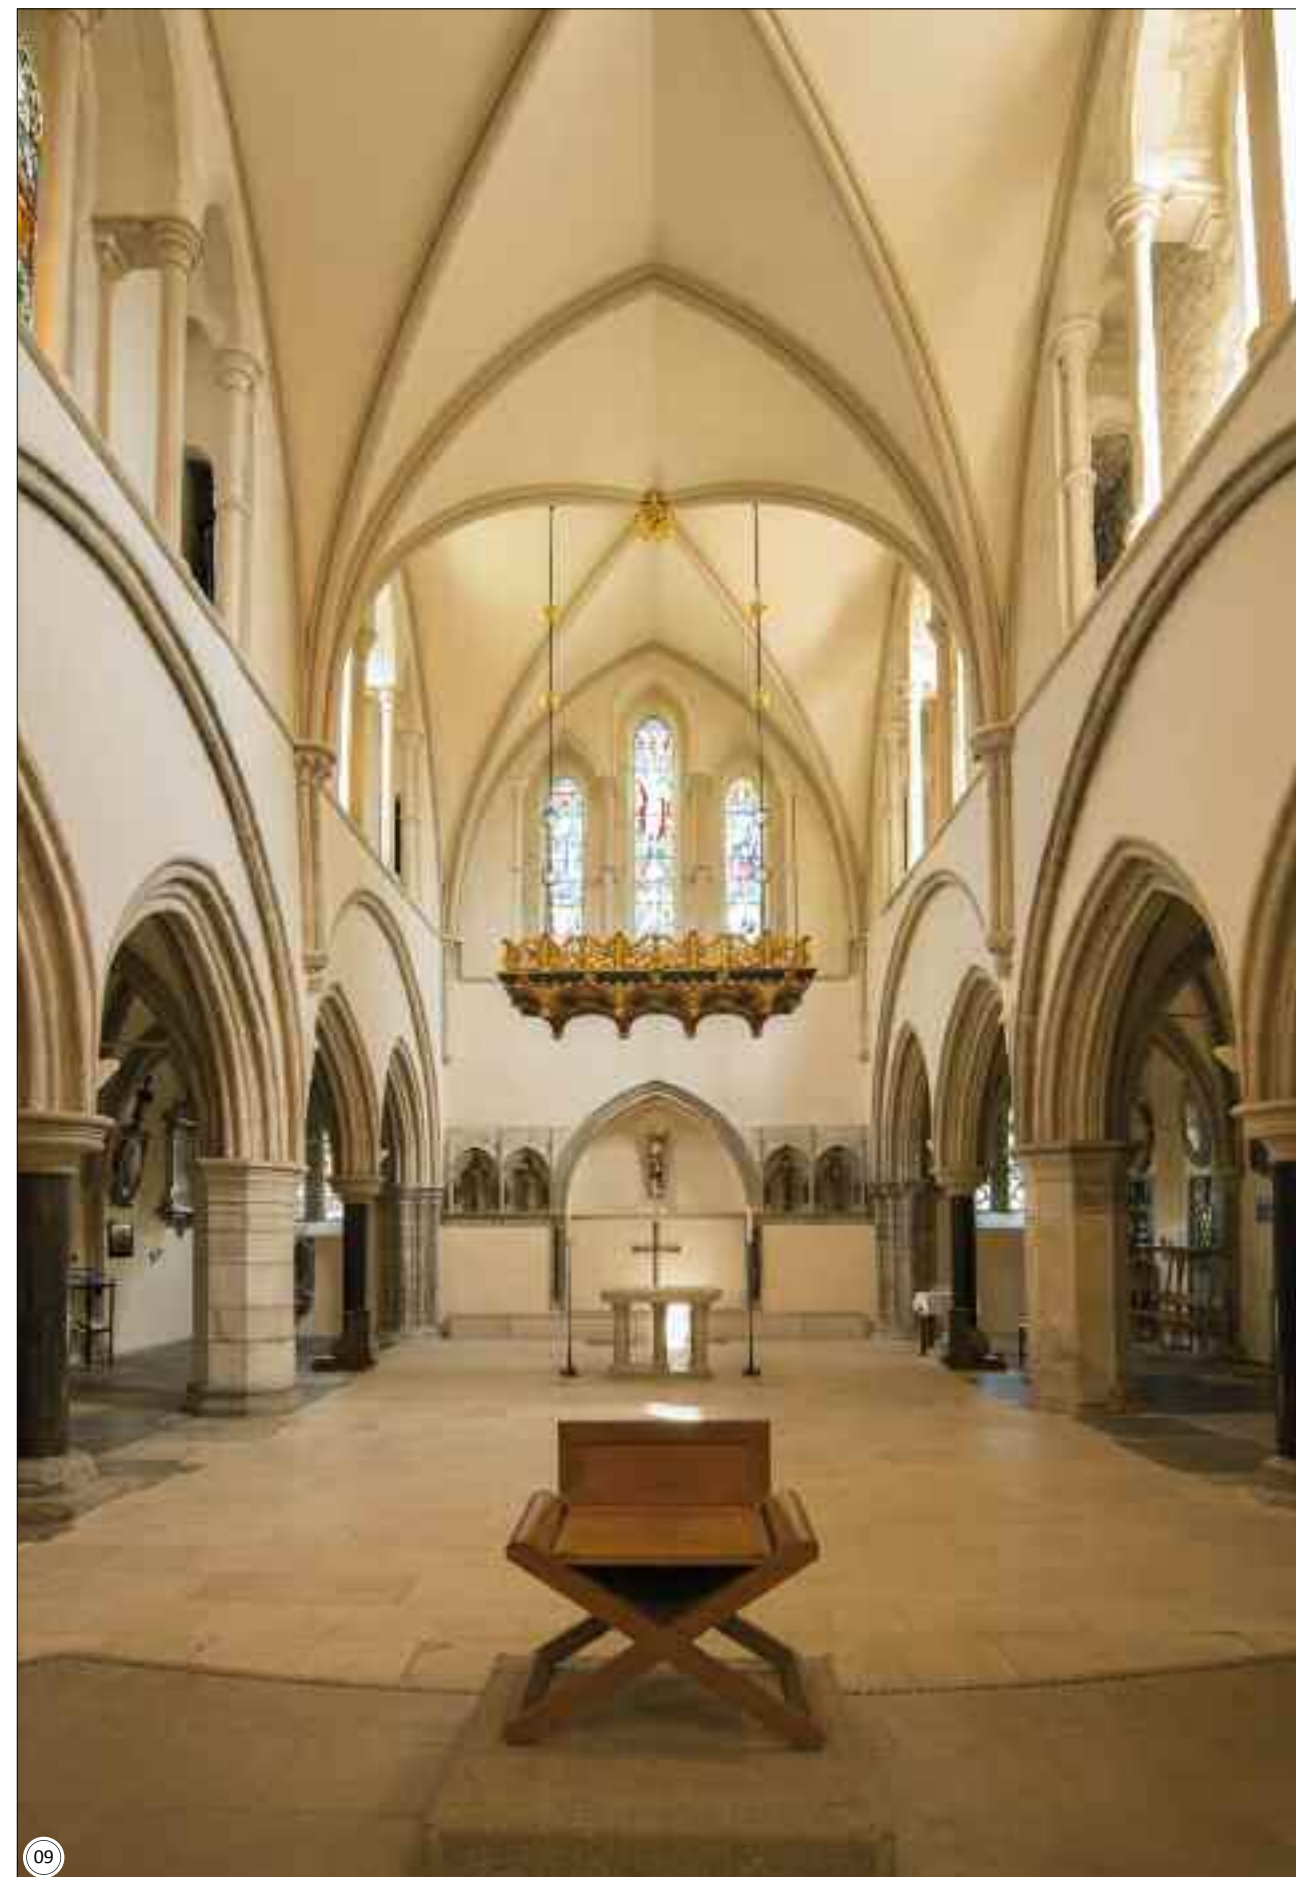
09 Chapel of St Thomas  
© Jonty M Sexton

Getting close to the Victorian lath and plaster mock vaulting in the chapel of St Thomas was also rewarding. The bold plaster bosses had small pieces of charred material caught in the mouldings – presumably from the Second World War. The bosses were re-gilded as were the spheres on the rods supporting Nicholson's tester above Michael Drury's altar of the 1990s.
